FireCR Dental AH type

FireCR Dental AJ type

Tray assembly motion NG

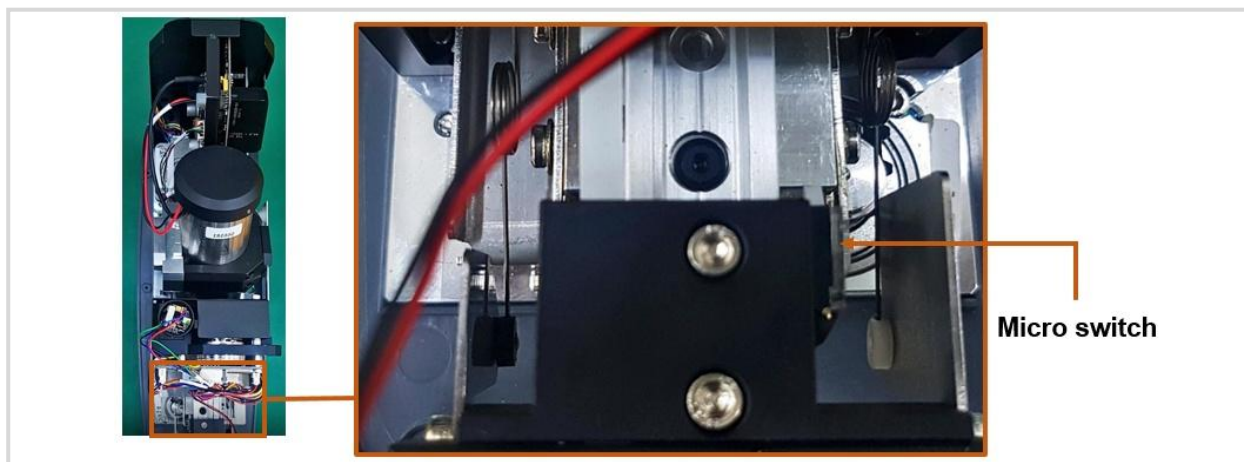
- 1) Broken micro switch.

Tray stuck during scanning phase.

Push a micro switch, a tray moves back and forth a little bit. If a tray does not move at all, a micro switch or a front board should be an issue. A micro switch is the part of the RFID board.

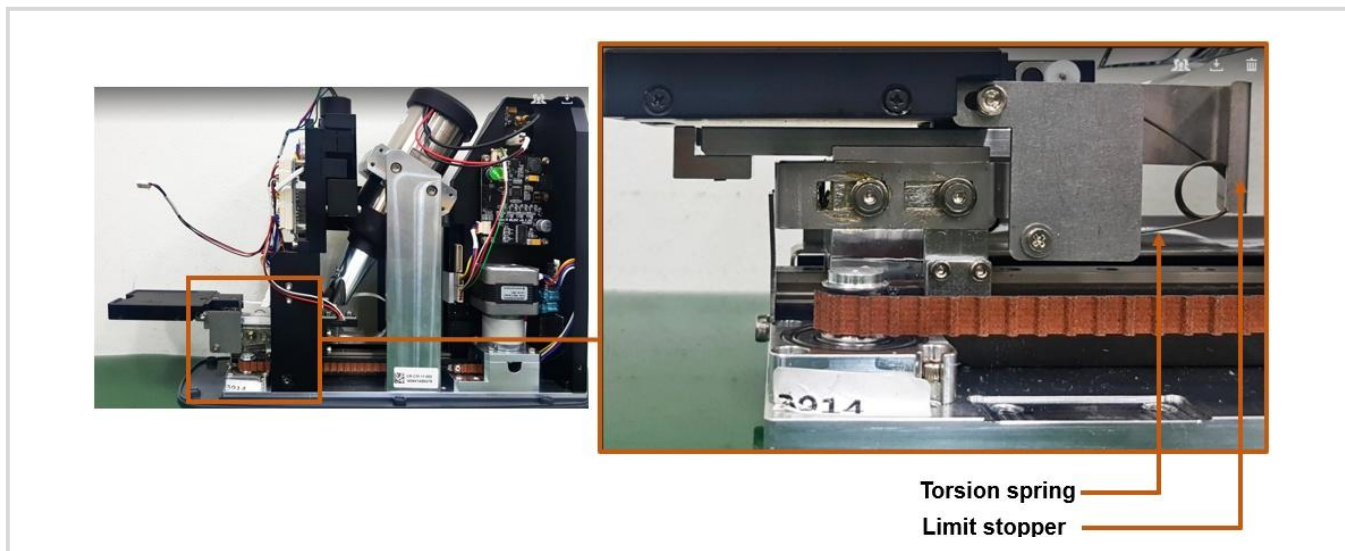
2) Contact between limit stopper and torsion spring

Torsion spring hits a limit stopper when a tray is pushed in. A tray ejects during scanning phase.

In this case, a limit stopper should be bent to avoid contact.

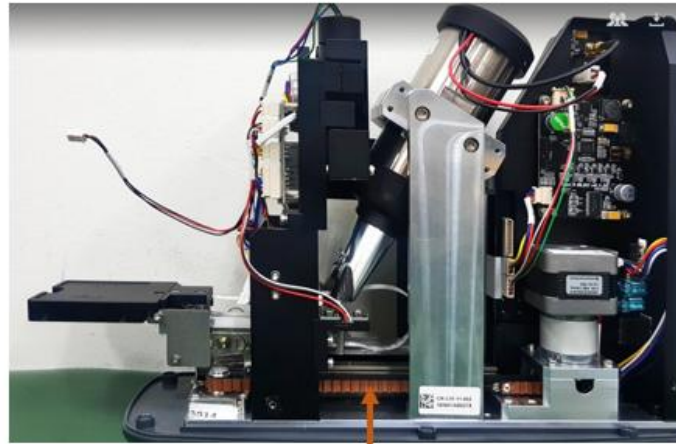
Belt assembly

Tray does not stop after scanning / erasing process

Replace a belt assembly
